5th Line Bridge (Bridge No. 09) Schedule 'C' Municipal Class Environmental Assessment

Environmental Study Report

Prepared For:
Township of Essa

PROJECT NO. 217031

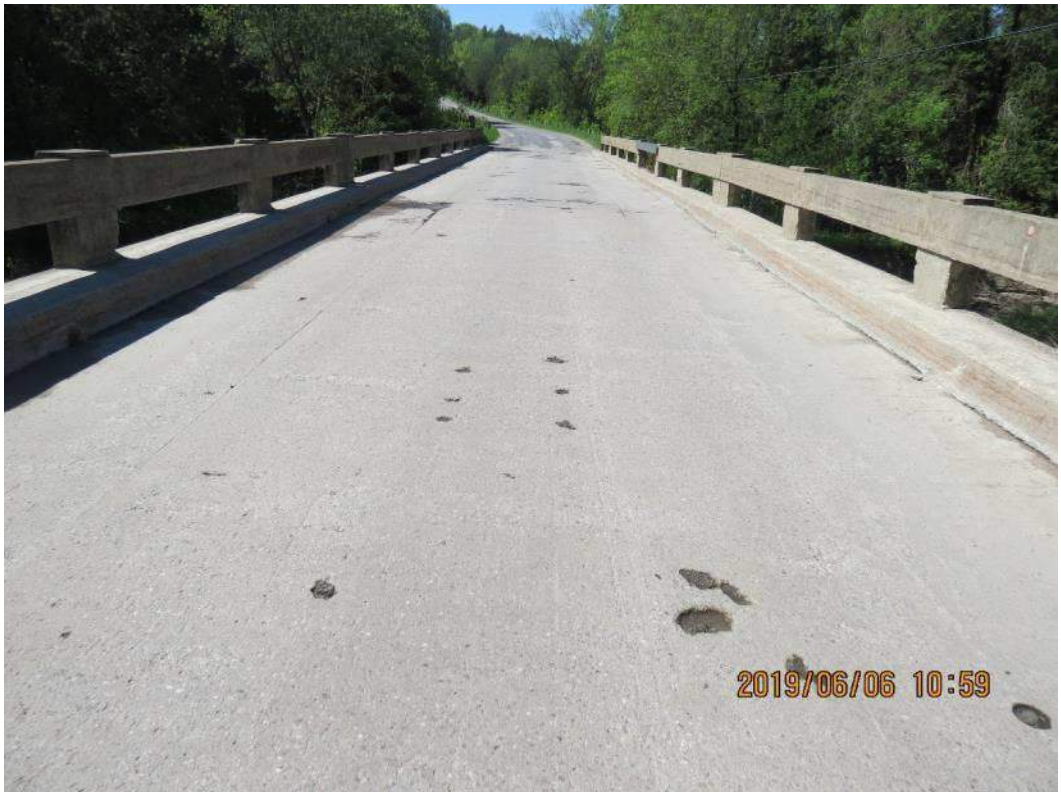
IMG_1512
 Typical Deck Top

Replace structure

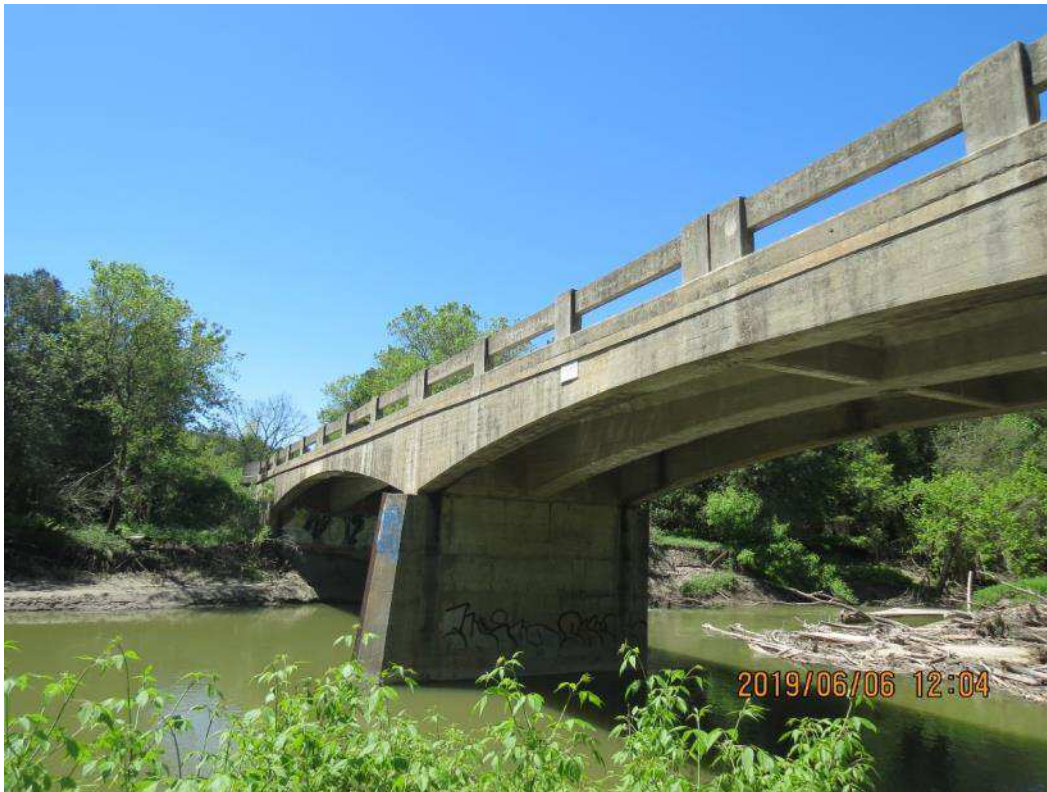
Element Group:*	Deck	Length:	51.8 m		
Element Name: *	Soffit	Width:			
Location:	East Fascia	Height:	0.5 m		
Material: *	Concrete, cast-in-place	Count:	1		
Element Type: *		Total Quantity:	25.9 m ²		
Environment:	Severe	Limited Inspection	<input type="checkbox"/>		
Protection System: *					Perform. Deficiencies
Condition Data:	Units	Exc.	Good	Fair	Poor*
	m ²		19.4	6.5	
Comments: Narrow Pattern cracking, with rust staining and light efflorescence Curb construction joint appears to be a longitudinal crack (full length)					
Recommended Work: <input type="checkbox"/> Rehab <input checked="" type="checkbox"/> Replace			Maintenance Needs:		N/A
<input type="checkbox"/> Urgent <input type="checkbox"/> 1-5 years <input checked="" type="checkbox"/> 6-10 years <input type="checkbox"/> None			<input type="checkbox"/> Urgent <input type="checkbox"/> 1 year <input type="checkbox"/> 2 year		
Replace structure

IMG_1748
East Fascia from North End

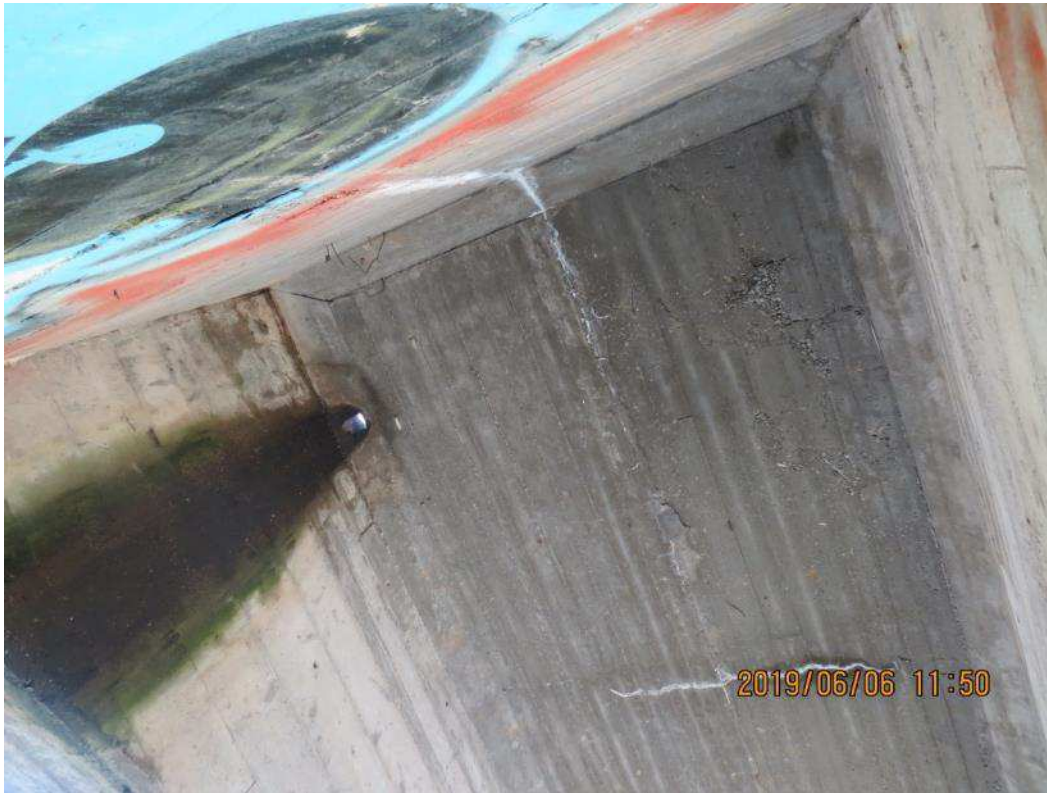
IMG_1700
Typical Soffit Deficiencies (1 of 2)

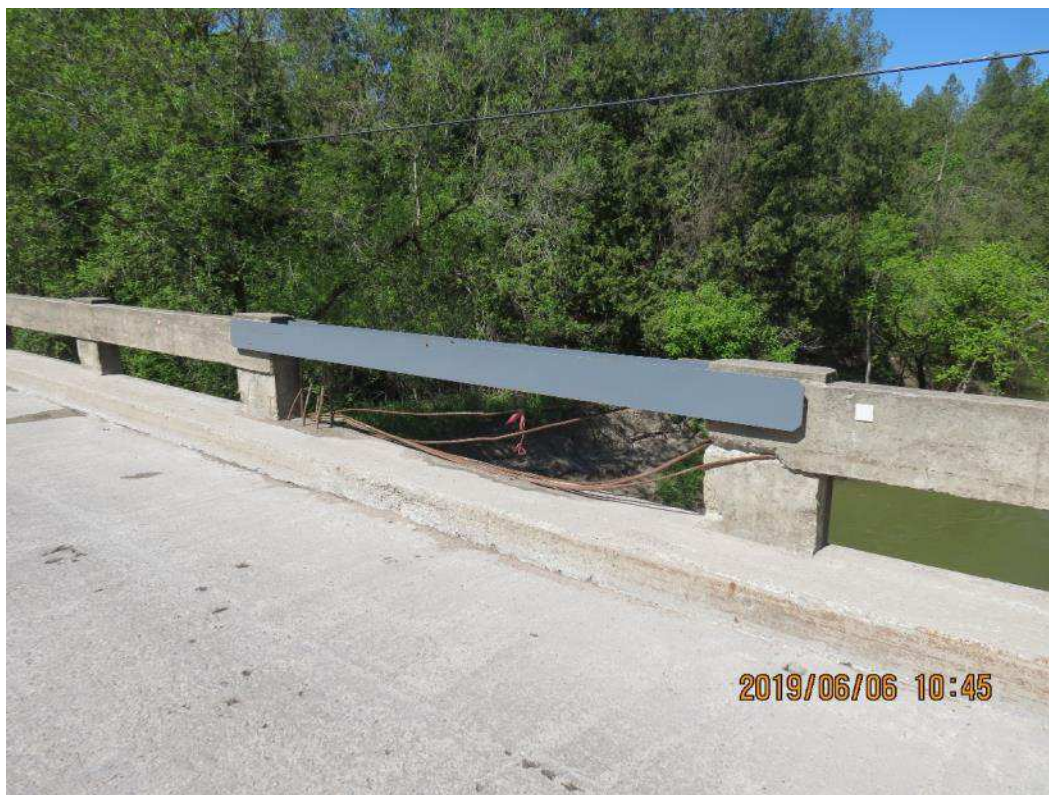
IMG_1401
West Railing Missing Section

Replace missing railing system

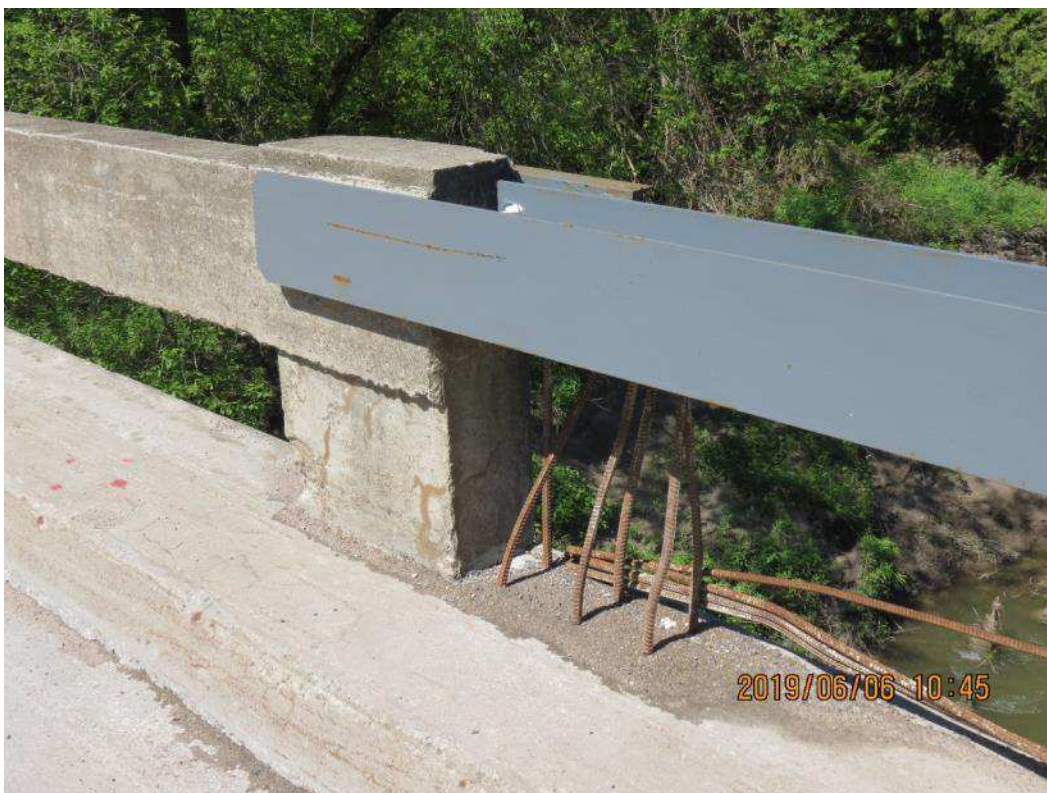
IMG_1403
Missing Concrete Post

Replace missing posts

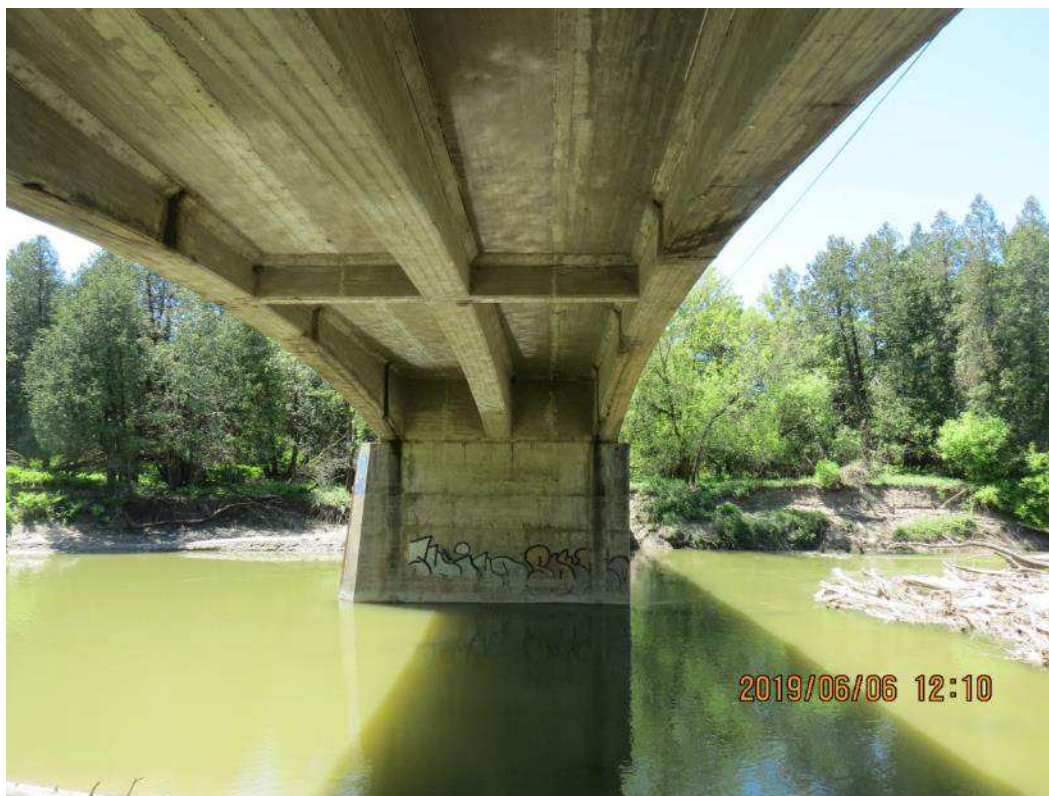
IMG_1674
Typical Exposed Rebar and Deterioration of Girders

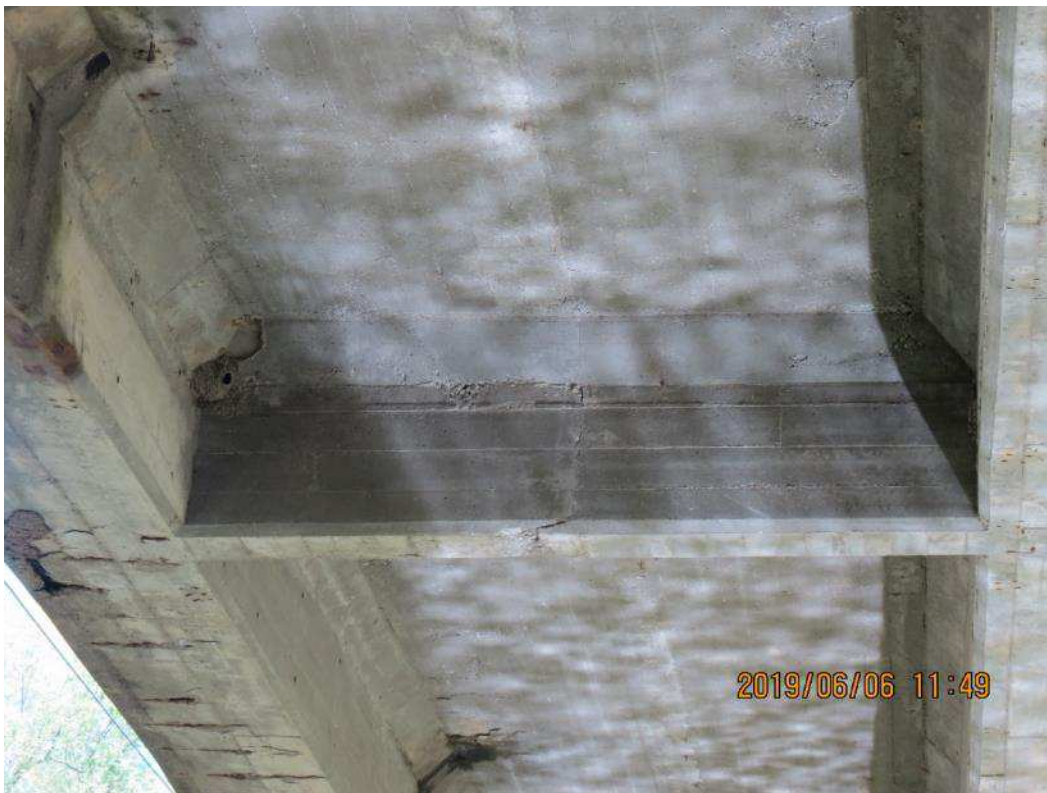
IMG_1692
Cracks in Diaphragm

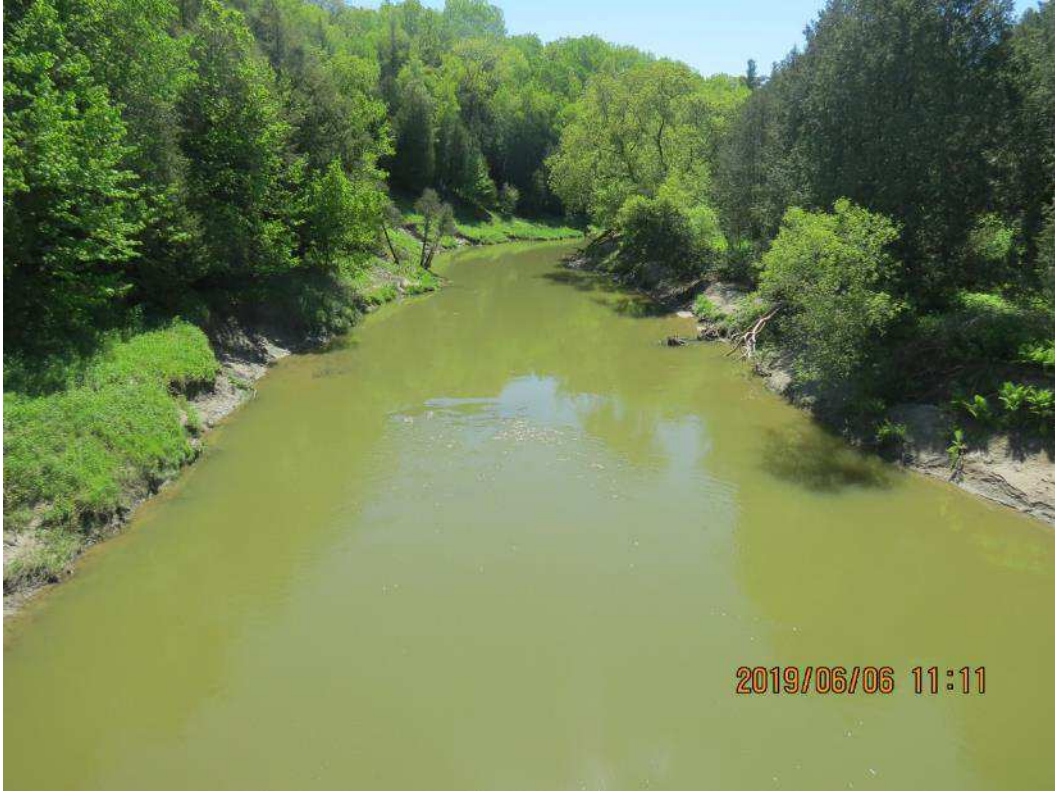
Element Group:*	Embankments & Streams			Length:	
Element Name: *	Streams and Waterways			Width:	
Location:				Height:	
Material: *				Count:	
Element Type: *				Total Quantity:	All
Environment:				Limited Inspection	<input type="checkbox"/>
Protection System: *					Perform. Deficiencies
Condition Data:	Units	Exc.	Good	Fair	Poor*
	All			X	
Comments: East-West flow of water Debris buildup (blockage) on west side of structure					
Recommended Work: <input type="checkbox"/> Rehab <input type="checkbox"/> Replace				Maintenance Needs: 18	
<input type="checkbox"/> Urgent <input type="checkbox"/> 1-5 years <input type="checkbox"/> 6-10 years <input checked="" type="checkbox"/> None				<input type="checkbox"/> Urgent <input checked="" type="checkbox"/> 1 year <input type="checkbox"/> 2 year	
				Remove debris buildup	
Element Photo:

2019/06/06 11:11 IMG_1576 River Looking Upstream
